Manhole Inspection Summary

Manhole # S35WW_010MH

Insp Date: **1/8/07 11:11 AM**

Location Address: **3046 GUILFORD AVE**

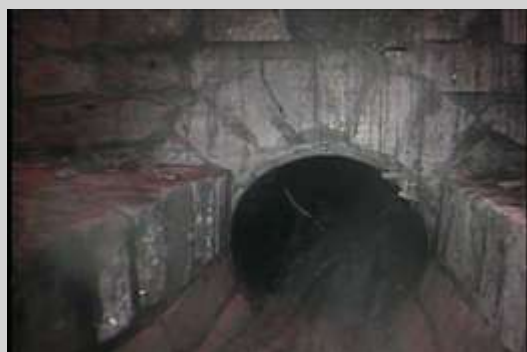
Pipe Out @ 12 O'Clock

10 in. Circular Gravity Sewer

Pipe Material: **Clay** ☐ Pipe Lined

Infiltration: **None** Pipe Seal Cond: **Unknown**
